5.0 RECORDS REVIEW

We have performed a Phase I Environmental Site Assessment of the Property at South of Glenn Ranch Road East of Saddleback Ranch Road, Lake Forest, Orange County, California in conformance with the scope and limitations of ASTM Standard Practice E 1527-05. Exceptions to, or deletions from, the standard practice are described in Section 1.2 of this report. This assessment did not reveal evidence of recognized environmental conditions in connection with the Property.

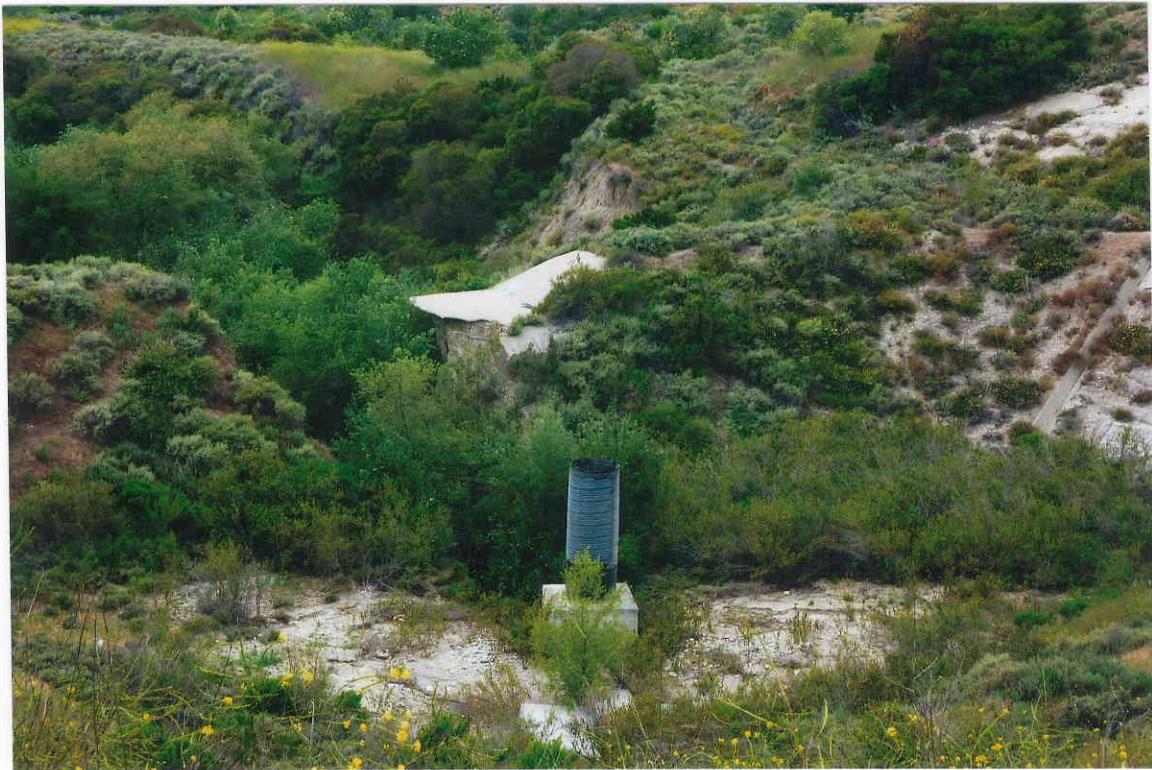
On the northwest end of the Property near Glenn Ranch Road a storm water retention basin was observed. Staining basin due to the improper disposal of hazardous substances and waste was not observed.

STORM WATER RETENTION BASIN, NORTH PORTION PARCEL 606-341-08

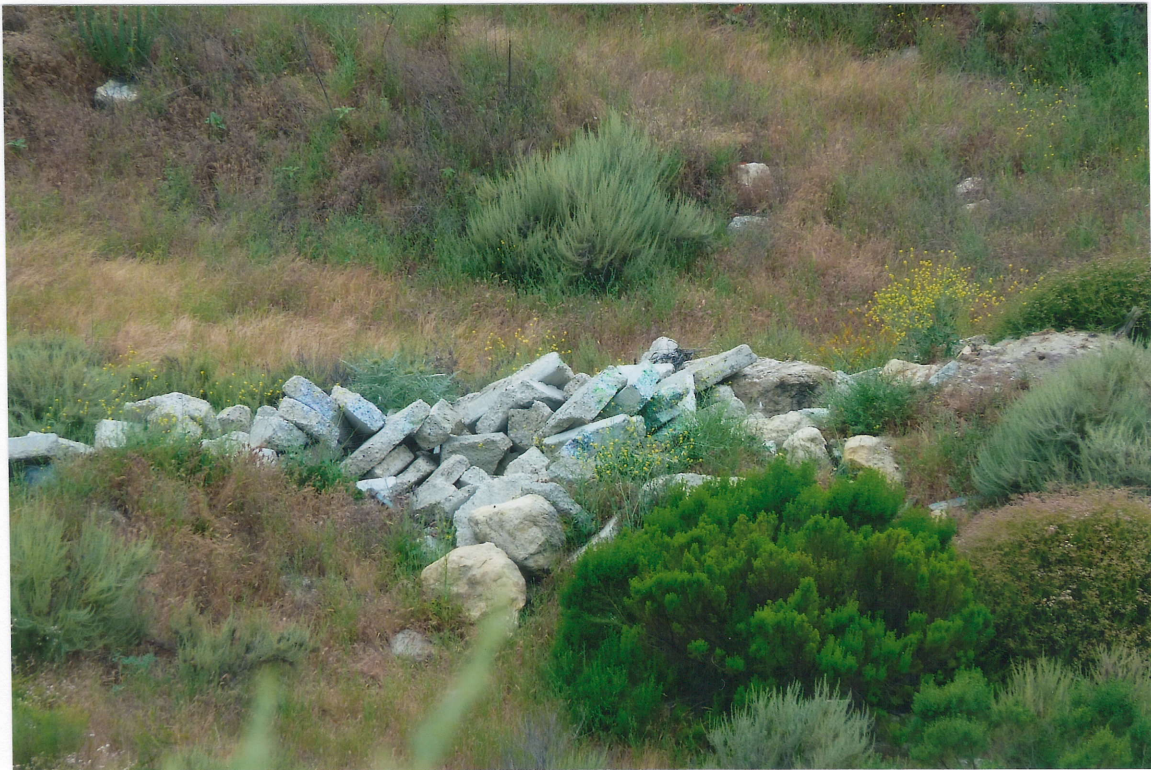
A minor amount of non-hazardous trash was observed. A 100-yard row of dumped concrete rubble was observed in the central north portion of the Property, approximately along the line between parcels 606-351-03 and -02.

CONCRETE RUBBLE IN NORTH CENTRAL PORTION OF PROPERTY
